Owls Hall
ENVIRONMENTAL

Case Study: Mr & Mrs Quee
6-12 person
treatment plant

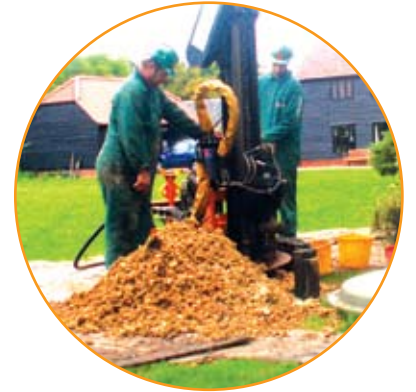
Owls Hall Environmental were contacted regarding a failing sewage treatment plant. An Engineer was immediately sent to site to help assess the problem. It was established that part of the tank structure was bulging at the bottom and thus had caused a split in the tank which was allowing groundwater to enter the system.

The actual processing section of the treatment plant was operating correctly however with the added groundwater leaking into the system, this was discharging outside the limits of their 'Consent to Discharge Licence' as regulated by the Environment Agency

Due to the saturated ground water surrounding the tank, it was necessary

to drain it prior to starting the repair work. This needed to be done over a few days due to the makeup of the soil. As a result, A bore hole was installed allowing a silent running pump to be installed in order to minimise the disruption caused to both the customer and their neighbours.

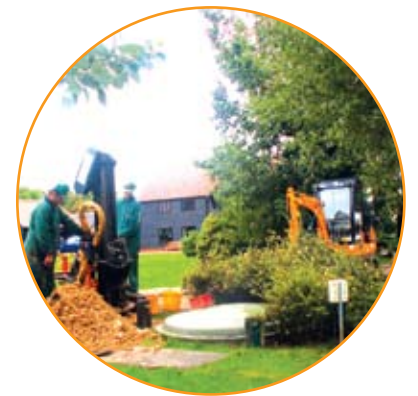
The treatment plants components were completely removed to allow access to the bottom of the tank to allow the repair and strengthening

bars to be inserted to provide durability greater than a new machine and to help prolong the life of the system for Mr. & Mrs. Quee.

The repair work was carried out on time and little evidence of the work was left except for a fully functioning Sewage Treatment Plant and a happy customer. All the work was also covered by their insurance company, Saga insurance to their complete satisfaction.
